# New Hampshire Volunteer Lake Assessment Program

## 2003 Interim Report for Gould Pond Hillsboro

NHDES  
Water Division  
Watershed Management Bureau  
29 Hazen Drive  
Concord, NH 03301

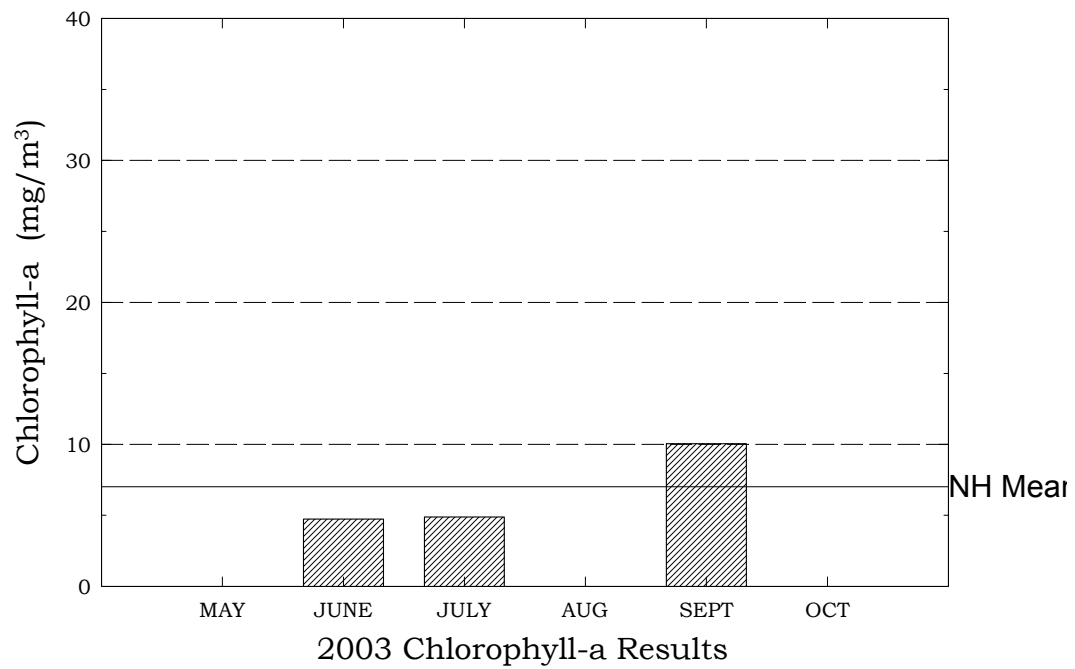
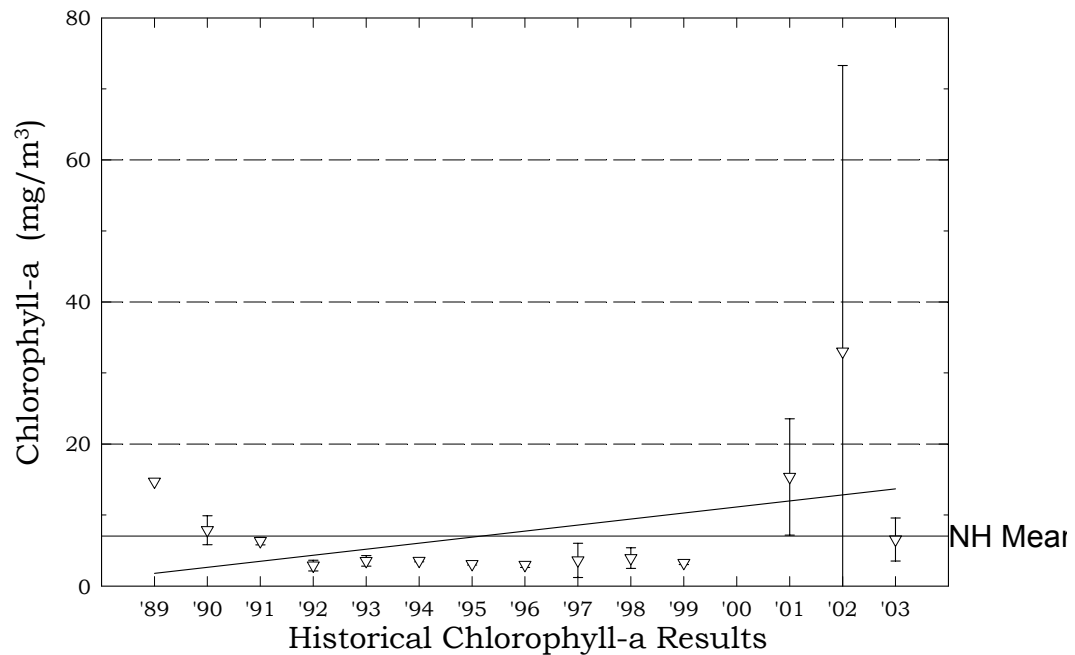
**Figure 1.** Monthly and Historical Chlorophyll-a Results

The current year data (the top graph) show that the chlorophyll-a concentration **remained stable** from June to July, and then **increased** from July to September. *(Please note that the pond was not sampled in August. The September sampling event was conducted on September 2).* The chlorophyll-a concentration in June and July was **less than** the state mean, while the concentration in September was **greater than** the state mean.

The historical data (the bottom graph) show that the 2003 chlorophyll-a mean is ***approximately equal to*** the state mean.

Overall, visual inspection of the historical data trend line (the bottom graph) shows ***a variable*** in-lake chlorophyll-a trend. Specifically, the mean annual chlorophyll concentration has ***fluctuated***, but has *not continually increased or continually decreased*, since monitoring began in 1989. After 10 consecutive years of sample collection, we will conduct a statistical analysis of the historic data to objectively determine if there has been a significant change in the annual mean chlorophyll-a concentration since monitoring began. (Please note that the pond was not sampled in 2000.)

While algae are naturally present in all lakes/ponds, an excessive or increasing amount of any type is not welcomed. In freshwater lakes/ponds, phosphorus is the nutrient that algae depend upon for growth. Algal concentrations may increase with an increase in nonpoint sources of phosphorus loading from the watershed, or in-lake sources of phosphorus loading (such as phosphorus releases from the sediments). Therefore, it is extremely important for volunteer monitors to continually educate residents about how activities within the watershed can affect phosphorus loading and lake/pond quality.

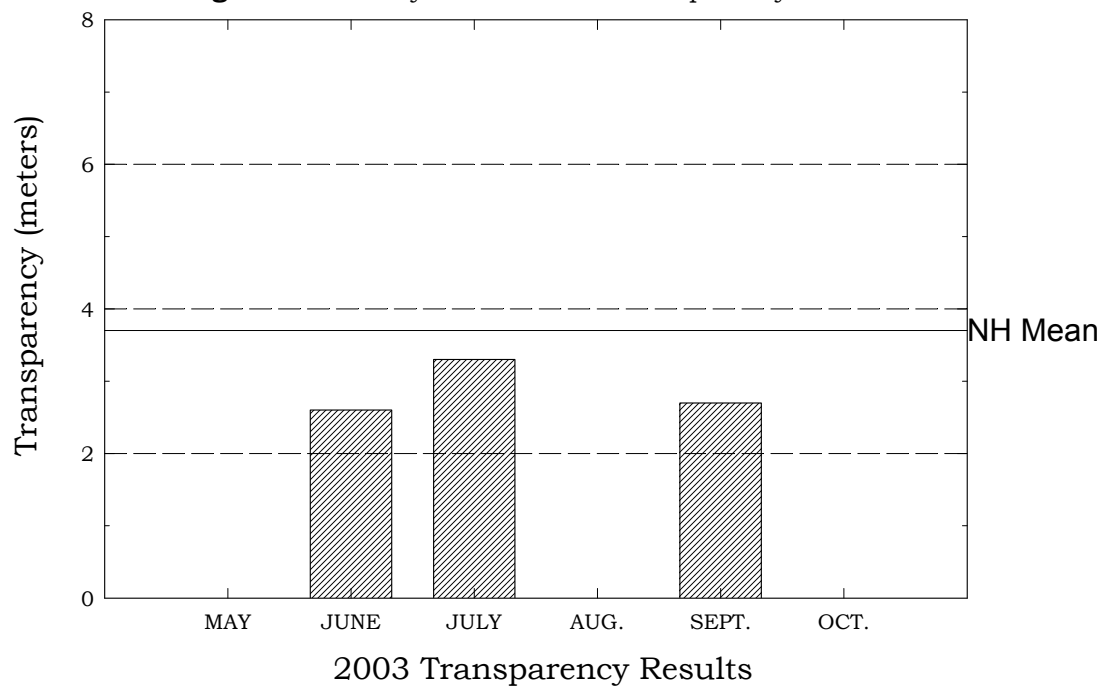
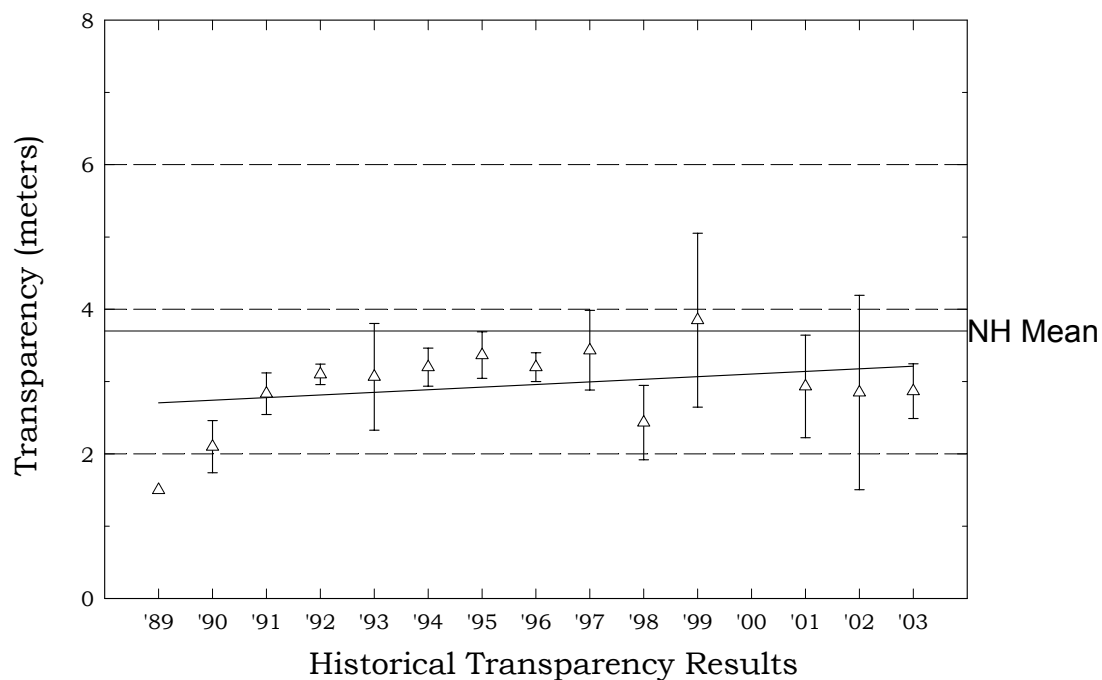
**Figure 2.** Monthly and Historical Transparency Results

The current year data (the top graph) show that the in-lake transparency ***increased*** from June to July, and then ***decreased*** from July to September. The transparency on each sampling event was ***less than*** the state mean.

Overall, visual inspection of the historical data trend line (the bottom graph) shows ***a slightly increasing*** trend for in-lake transparency, meaning that the transparency has ***slightly improved*** since monitoring began in 1989. As discussed previously, after 10

consecutive years of sample collection, we will conduct a statistical analysis of the historic data to objectively determine if there has been a significant change in the annual mean transparency since monitoring began.

Typically, high intensity rainfall causes erosion of sediments into lakes/ponds and streams, thus decreasing clarity. Efforts should continually be made to stabilize stream banks, lake/pond shorelines, disturbed soils within the watershed, and especially dirt roads located immediately adjacent to the edge of tributaries and the lake/pond. Guides to Best Management Practices designed to reduce, and possibly even eliminate, nonpoint source pollutants, such as sediment loading, are available from DES upon request.

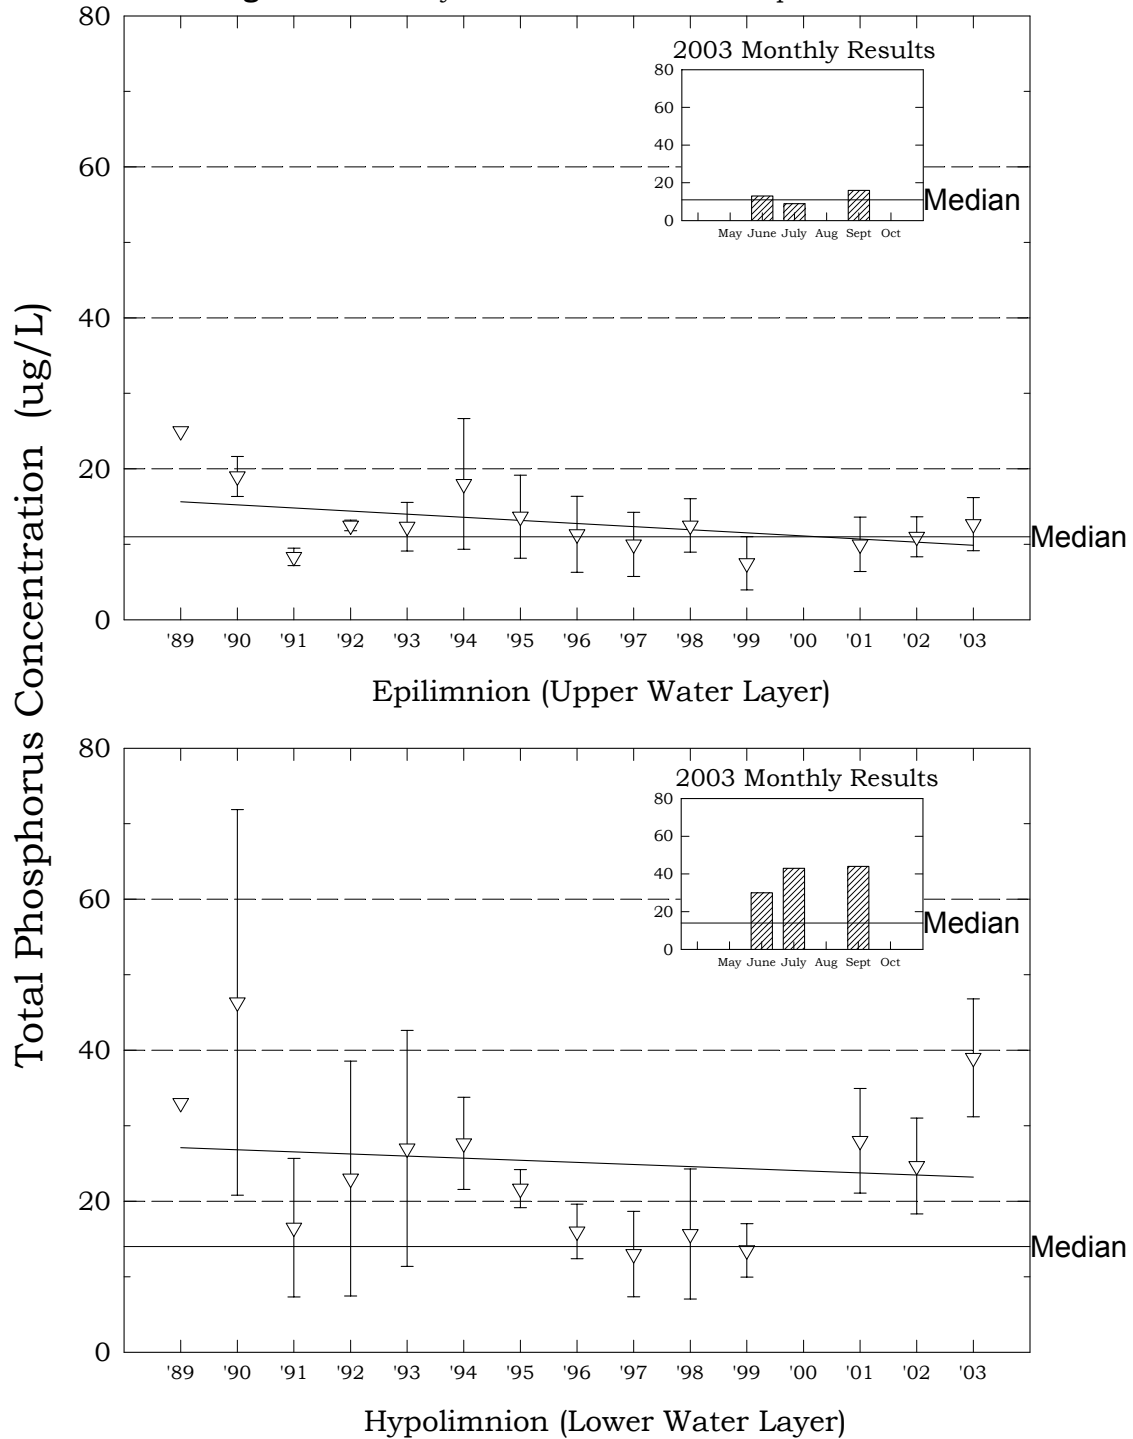
**Figure 3.** Monthly and Historical Total Phosphorus Data.

The current year data for the epilimnion (the top inset graph) show that the phosphorus concentration **decreased** from June to July, and then **increased** from July to September. The phosphorus concentration in June and September was **slightly greater than** the state median, while the concentration was **slightly less than** the state median in July.

The historical data show that the 2003 mean epilimnetic phosphorus concentration is **approximately equal to** the state median.

The current year data for the hypolimnion (the bottom inset graph) show that the phosphorus concentration **increased** from June to July, and then **remained stable** from July to September. The phosphorus concentration on each event was **greater than** the state median.

The historical data show that the 2003 mean hypolimnetic phosphorus concentration is ***much greater than*** the state median.

Overall, visual inspection of the historical data trend line for the epilimnion shows a ***relatively stable*** phosphorus trend since 1991.

Overall, visual inspection of the historical data trend line for the hypolimnion shows a ***variable*** phosphorus trend, which means that the concentration has ***fluctuated*** in the hypolimnion since monitoring began.

It is also important to point out that the phosphorus concentration in the hypolimnion has typically been ***much greater than*** the phosphorus concentration in the epilimnion. This data indicates that ***internal phosphorus loading*** is occurring in the hypolimnion. (Please refer to the discussion of Table 9 and 10 for a detailed explanation of internal total phosphorus loading.)

One of the most important approaches to reducing phosphorus loading to a waterbody is to continually educate watershed residents about its sources and how excessive amounts can adversely impact the ecology and value of lakes and ponds. Phosphorus sources within a lake or pond's watershed typically include septic systems, animal waste, lawn fertilizer, road and construction erosion, and natural wetlands.
